Pacojet: shaft stuck in extended (down) position; beaker cannot be removed! No problem as it can be wound up back to starting position by hand as follows:

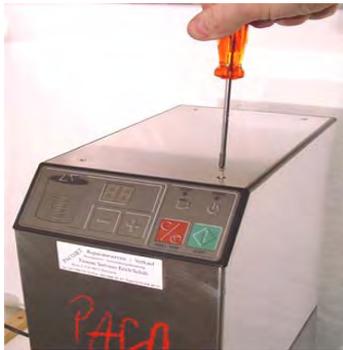
Remove metal top plate (4 screws)

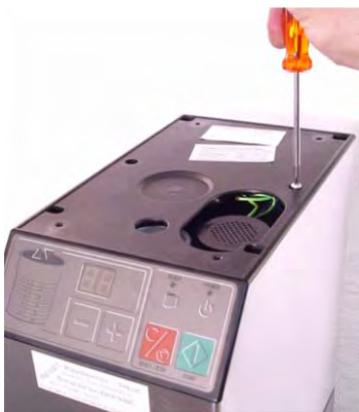
Remove the 6 sunken screws of black plastic top cover.

Note: should one of the middle screws be covered by a **red** or **blue** plastic cap, pry (prise) it out with a pointed object.

Note: removal of **red** color plastic cap requires prior approval of Pacojet AG as otherwise removal will void the warranty (pls. telephone +41-41-7102522 and advise serial number, which can be found on floor plate (bottom) of the machine (turn it upside down to see the 10 or 11 digit number (big numerals) on the specification label).

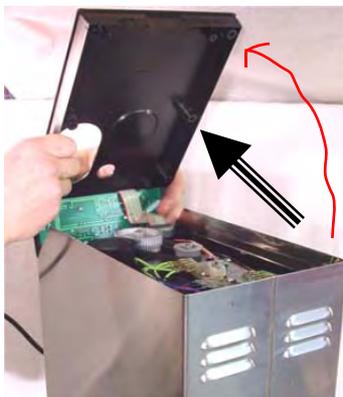
Next, grasp top cover at back side and gently lift it up as shown
